## Reconstruction

- three month expenditure of time for rebuilding and improvement

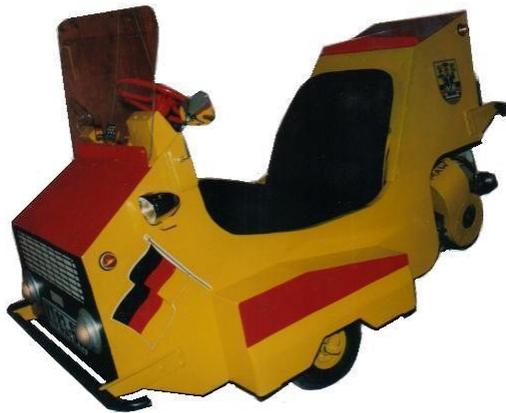
- fender and rear plate are plywood strengthened
- steel edges to protect chassis underbody on the outside
- three chain adjuster for fitting angle of contact of sprocket wheels

- two self-wound spoolings at contact breaker blank (shifted by 180°) with bridge rectifier each for battery charging
- electric 6-fold-melting-protective device

- battery 6V 11Ah "Simson S50/51"
- integral charging set  $\approx 230V / =7v, 0.1A$
- digital display of battery voltage
- two bicycle headlamps used as fog lights

- two rear view mirrors of motorbike "Schopper"
- fuel filter of passenger car "Lada"
- crossed-steering steel-cable, diameter 3mm, length 7m, not lubricated

- steering wheel shaft with electric carbon brushes for signal horn
- minimisation of laminated sheet package within exhaust pipe from eight to two semi-circular (damping) sheets, so that the motor has enough power  
After a one-time trip of 50km cross-country in the summer of 1980 the vehicle had to drive the last kilometers without any payload because the motor had no power. The at first unfathomable reason for the problem was cleared after an extensive examination. The exhaust system was almost completely clogged up with oil carbon and was blocked
